48 year old man presents with slowly increasing hip pain for ultrasound assessment

Ultrasound findings:

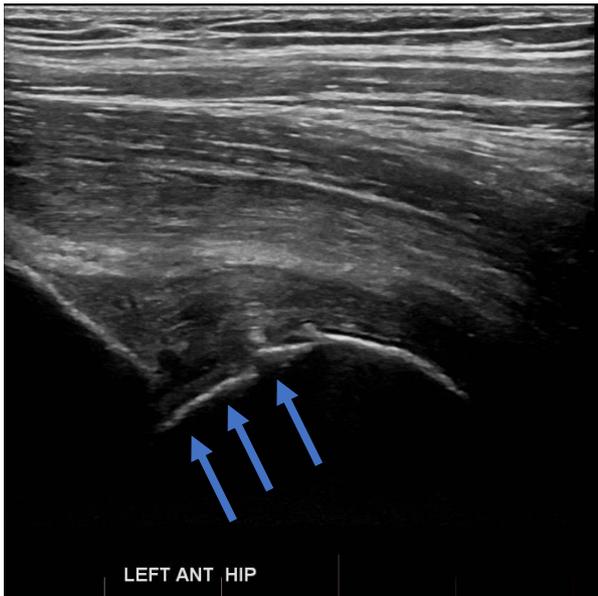
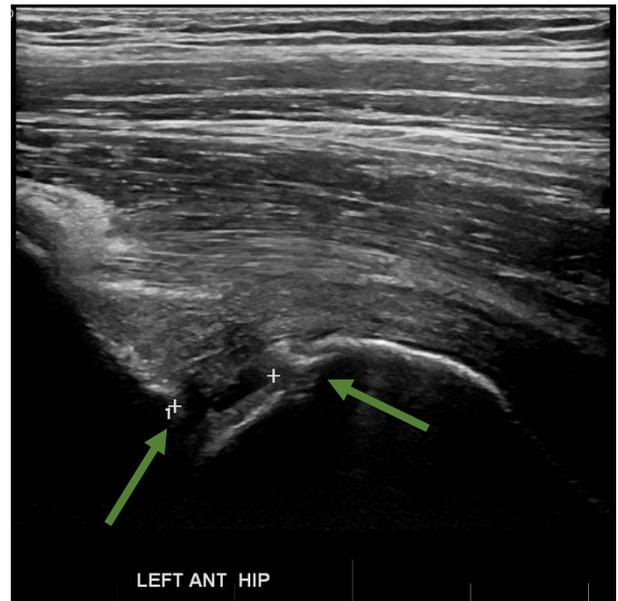
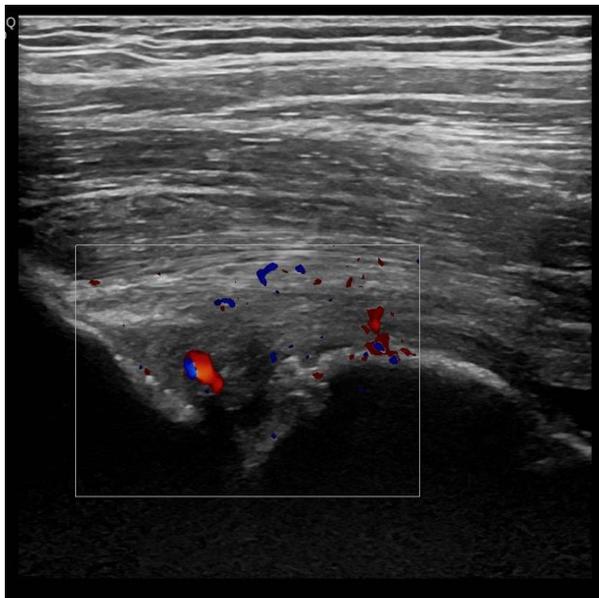
ULTRASOUND HIP: Discontinuity of the normal smooth articular margin of the femoral head (blue arrows), with a well defined step deformity (green arrows). The overlying hip capsule is thickened and hyperaemic, but the patient had minimal probe tenderness in this region (image on the left). The unusual appearance of the femoral head on ultrasound prompted an X-ray:

- Hip capsule thickening and hyperaemia
- Irregular appearance of the femoral head
- Disrupted articular margin of the femoral head with step deformity

- Usually not involved in assessment of AVN – in our case, the disrupted articular surface of a relatively young patient prompted further investigation

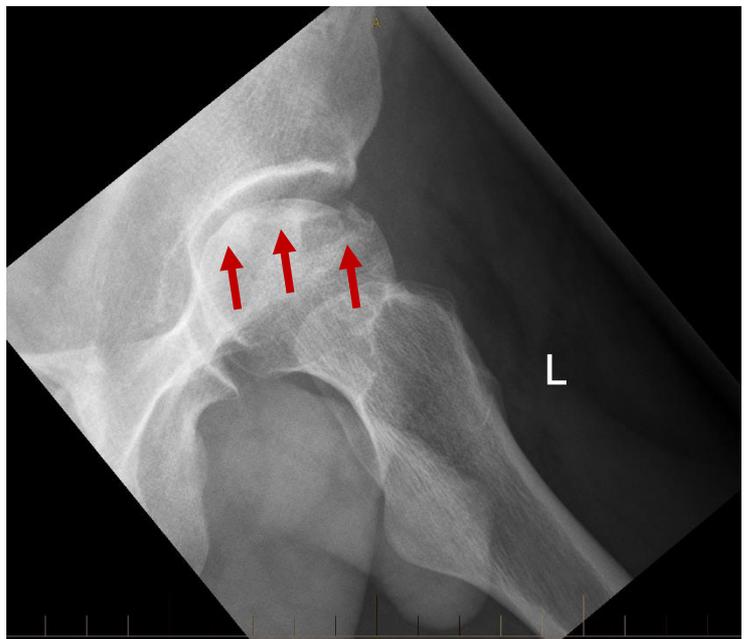
X-RAY HIP: The radiograph better shows the stigmata of established osteonecrosis of the femoral head: a sclerotic, fragmented and depressed articular margin. The step deformity indicated with the red arrow is the same area of articular disruption seen on the ultrasound image above marked with a blue arrow.

- Key point – Xrays are of low sensitivity for identification of AVN. A normal X-ray does not exclude AVN.
- Patchy sclerosis of femoral head, represents new bone being laid down within/along necrotic trabecula
- Classic subchondral crescentic lucency – herald of impending articular surface collapse
